# Critical flood conditions in two beaches of the Portuguese central west coast

**Abstract:** Coastal flooding is expected to be one of the major impacts of climate change in the Portuguese continental territory. In this study beach morphological indicators and hydrodynamic forcings, assessed through field data, allow a comparative analysis of overtopping and flooding conditions in two beaches located in the Portuguese central west coast, Cova-Gala and São Pedro de Moel, during recent events. Results show that for the same hydrodynamic conditions beaches are differently affected. Water level and beach cross-shore profile gradient seem to be the main triggering factors for overtopping occurrence in Cova-Gala. In São Pedro de Moel beach, wave set-up and incoming wave direction can force inland inundation independently of the beach morphological state. These outcomes point out the importance of a comprehensive knowledge of the local factors in adequate flood hazard predictions and mitigation measures development.

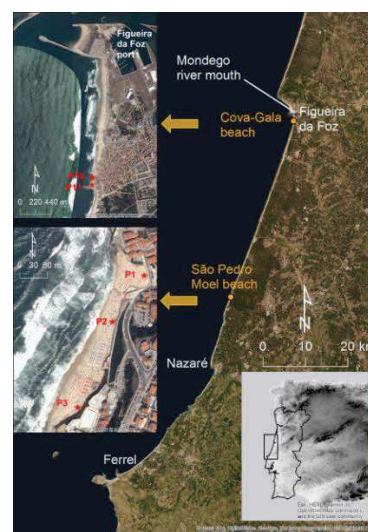
Fig. 1. Location of Cova-Gala and São Pedro de Moel beaches and studied cross-shore profiles (P10 and P11 in the first and P1, P2 and P3 in the second beach, respectively).

Two beaches vulnerable to coastal flooding and presenting different coastal typologies were chosen (Figure 1): Cova-Gala, located south of the Mondego river mouth south jetty, in Figueira da Foz, and São Pedro de Moel located 4 km further south. Cova-Gala is a sandy beach-dune system with a coastline length of approximately 2 km and a main alignment of 5°N. In the last five decades the beach has been changed due to several human interventions (Freire *et al.*, 2020), presenting nowadays five groynes and a seawall in its southern half sector. For the present study a stretch located in the southern sector of the beach with about 190 m, between two groynes and limited in the backshore by a seawall, was chosen

(Figure 1). Seawall average height in this location is 8.5 m above MSL (Mean seal level). Several infrastructures are present on the seawall top as a pedestrian platform with urban furniture. São Pedro de Moel beach is an embedded narrow beach with a coastline with approximately 400 m in length and main alignment of 25°N, limited by an active cliff at both extremes (Figure 1). Backshore, the beach presents a seawall with varying height between 5 and 7 m, and further south an alongshore defence structure with a southwards increasing height. On top of these structures several infrastructures are present as: a road, a square, a pedestrian path, and a view point with urban furniture. At the lower foreshore the beach shows rocky outcrops that are alternately covered and uncovered by sand.

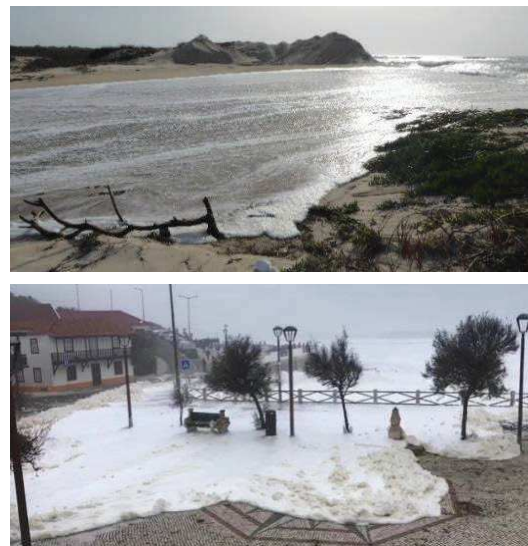
Fig. 2. Cova-Gala dune overwash on 21/02/2019 (photo above) and São Pedro de Moel inundation on 22/12/2019 (photo below).

On 21/02/2019, evidences of Cova-Gala seawall overtopping near profiles P10 and P11, during the first high tide level (04:00), were observed without noticeable impacts. In the afternoon high water level, extensive overwash of the dune located south of the southernmost groyne occurred promoting inland inundation with 30 m incursion (Figure 2). In São Pedro de Moel beach the water reached the seawall in profile P1 surrounding area but no overtopping took place. On 22/12/2019, oral testimonials mention overtopping of the seawall in P10 and P11 Cova-Gala beach profiles, and overflowing between P11 and the goyne. In São Pedro de Moel extensive downtown inundation occurred in profile P1 sector (Figure 2). The inundation took place around 12:00 near high tide level. Flooding impacts included people and vehicles circulation disruption and debris deposition on public roads. Maximum inland water incursion was about 30 m. Oral testimonies indicated this was the worst event affecting the village downtown after 2014 Hercules storm. Water level and wave parameters in the events days and the oceanographic

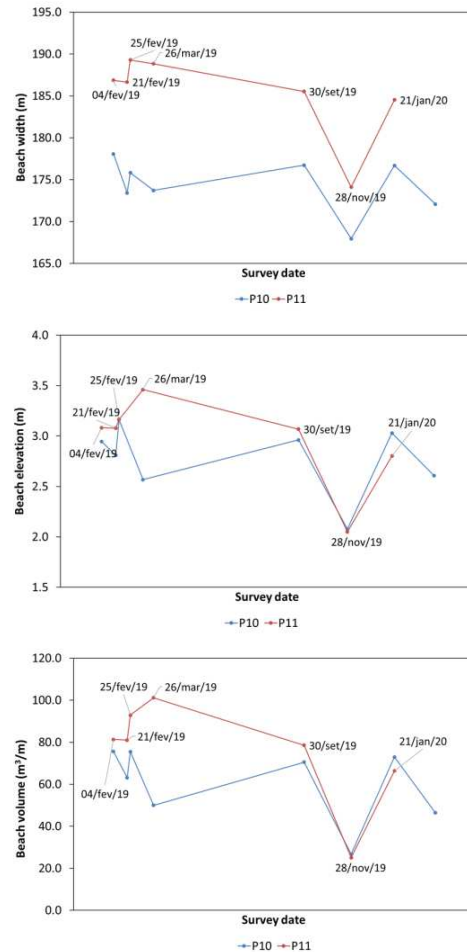
Fig 4. Morphological indicators of Cova-Gala beach: beach width (above), beach elevation (middle) and beach volume (bellow).

Results show that the survey prior to the December event (28/11/2019) corresponds to the less robust situation in Cova-Gala beach profiles P10 and P11. In this survey the three morphological indicators present the lowest values (Figure 4). On 21/02/2019 the beach shows a completely different morphological condition, in both profiles, as beach volume and average elevation is above all survey's average values. In this survey, only the beach width in profile P10 is lower than the average value in that survey. Prior to both events differences in the cross-shore morphology of the two surveys are evident (Figure 5): in November both profiles present lower elevation at the upper limit of the foreshore and profile P10 gradient is lower. The morphological indicators for São Pedro de Moel beach show profile P1 (located in the beach sector where the overtopping and flooding

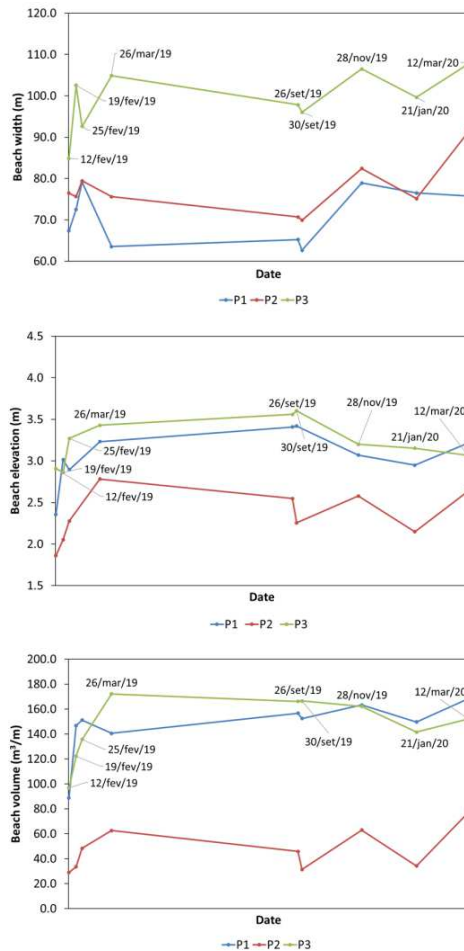
Fig. 6. Morphological indicators of São Pedro de Moel beach: beach width (above), beach elevation (middle) and beach volume (below).

occurred) presents a smaller beach width in all surveys (Figure 6). Before both February and December events, average beach width shows high values when compared to the other surveys. Also, on November 2019 beach volume is the second highest value observed. In both surveys, elevation of the foreshore upper limit is similar as is the cross-shore morphology, including the profile gradient. One can argue whether the November survey is representative of the beach morphological conditions immediately prior to the December event. Indicators comparison between the 28/11/2019 and 21/01/2020 surveys shows that no relevant changes occurred during this period.
