## **MOSAIC.PT FIELD CAMPAIGNS**

**Cova-Gala, Vieira and São Pedro de Moel beaches,  
January-March 2019**

MOSAIC.pt – Multi-source flood risk analysis for safe coastal  
communities and sustainable development

REPORT 334/2019 – **DHA/NEC**

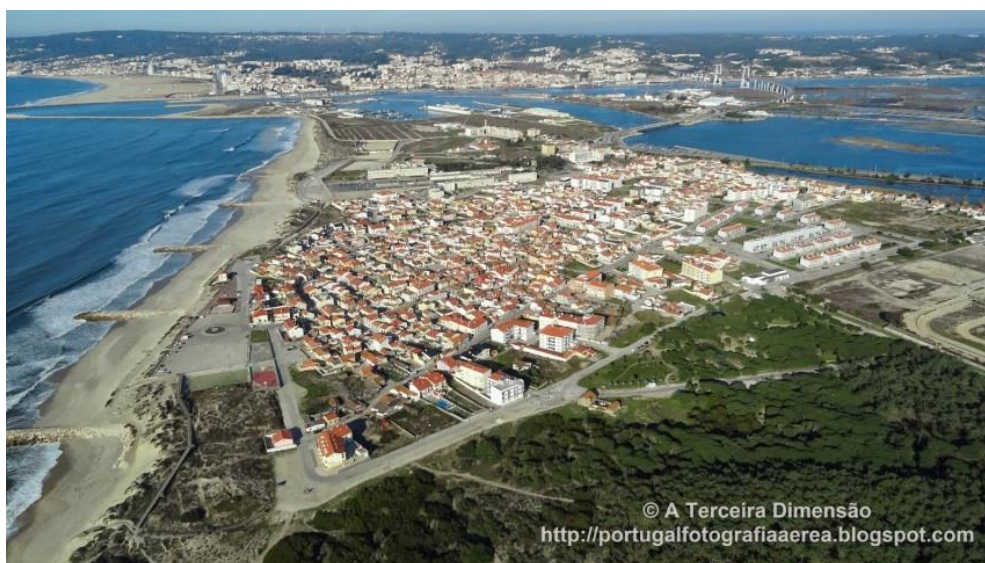
Figure 2.2 – Oblique aerial view of the seafront of Cova-Gala beach

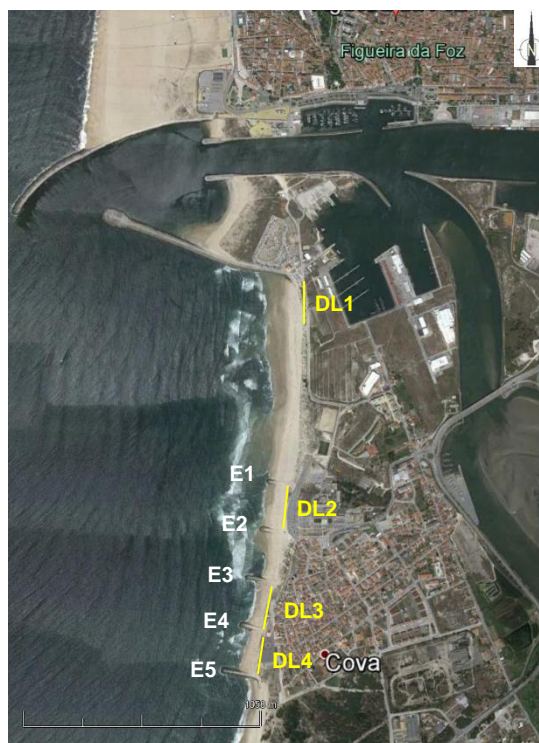
Figure 2.3 – Aerial photograph (18/6/2018; © Google Earth) of the Mondego river mouth and the coastal stretch of Cova-Gala, with its four alongshore defence structures (from DL1 to DL4) and five groynes (from E1 to E5)

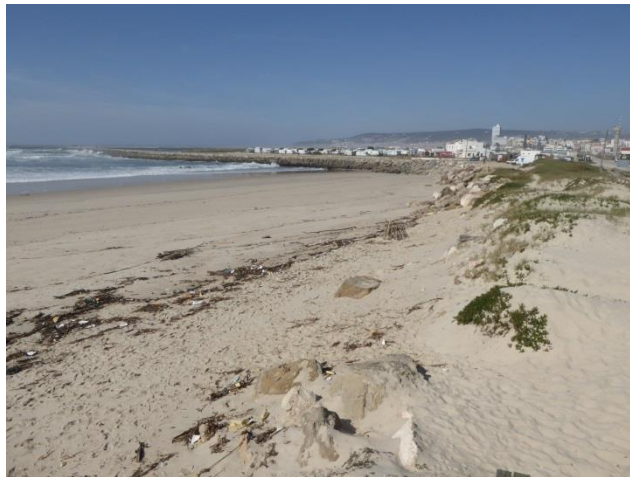
**Figure 2.4 – Photographs of Cova-Gala beach: view of the south jetty of the Mondego river mouth from the dune at the northern extreme of the beach (25/Feb/2019)**

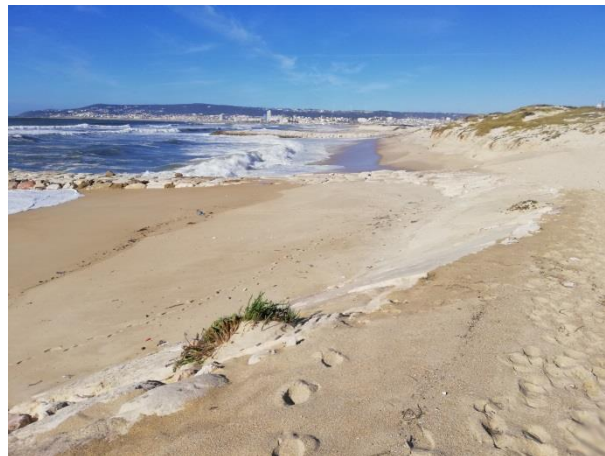
**Figure 2.5 – Photographs of Cova-Gala beach: view, towards the north of the beach, of E2 and E3, from the sedimentological cell between E3 and E4 (19/Feb/2019)**

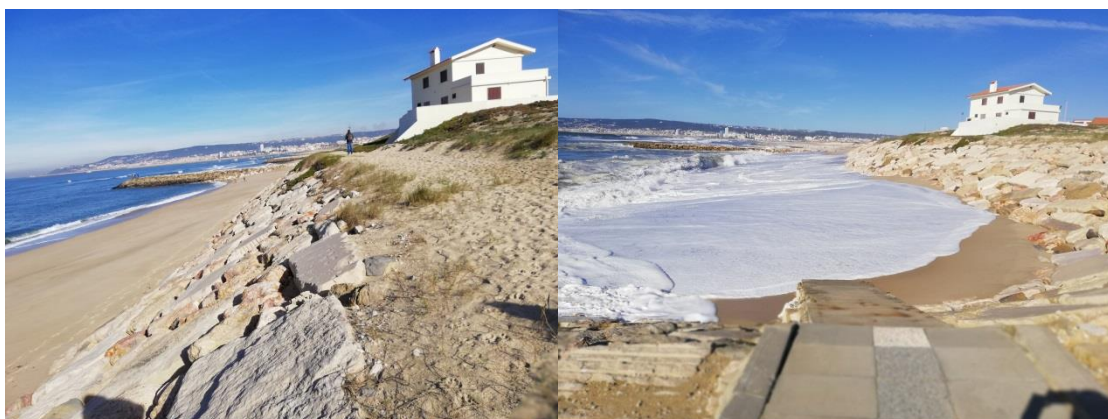
**Figure 2.6 – Photographs of Cova-Gala beach: view towards the north of the beach from the sedimentological cell between E3 and E4, at low and high tide (left and right, respectively) (21/Feb/2019)**

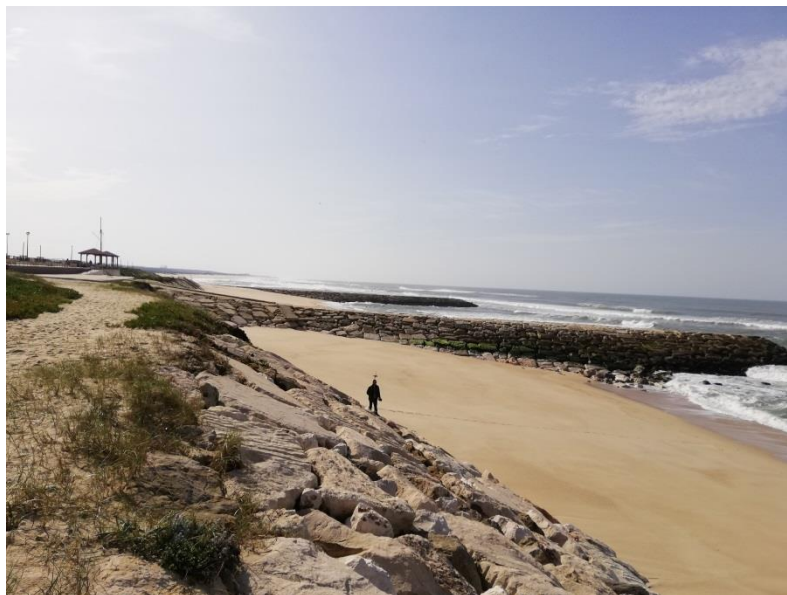
**Figure 2.7 – Photographs of Cova-Gala beach: view, towards the south of the beach, of E4 and E5, from the sedimentological cell between E3 and E4 (21/Feb/2019)**

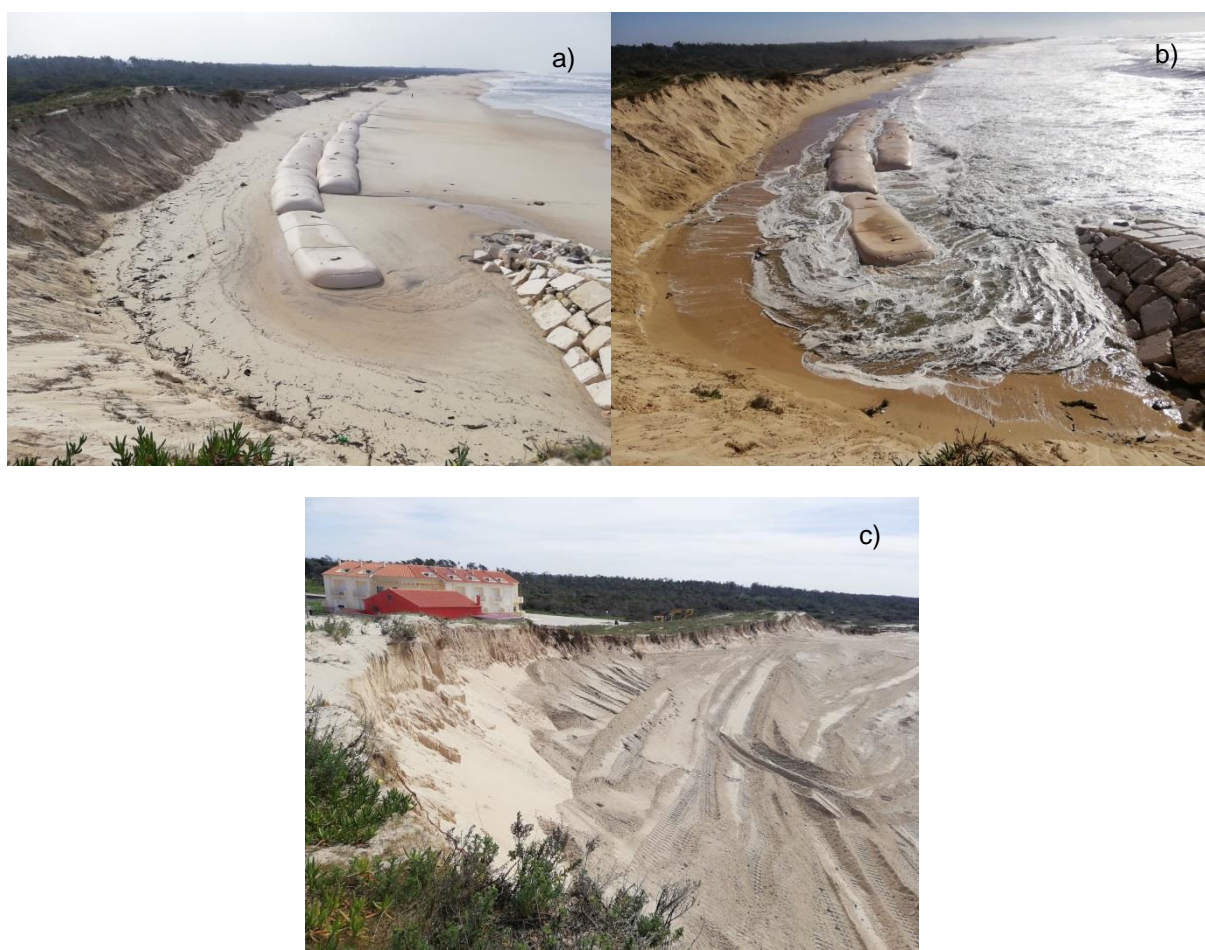
**Figure 2.8 – Photographs of Cova-Gala beach: adjacent downdrift zone of the groyne further south, E5, during and after the implementation of geotextile tubes for coastal protection: a) 21/Feb/2019, b)19/Feb/2019 and c) 26/March/2019**

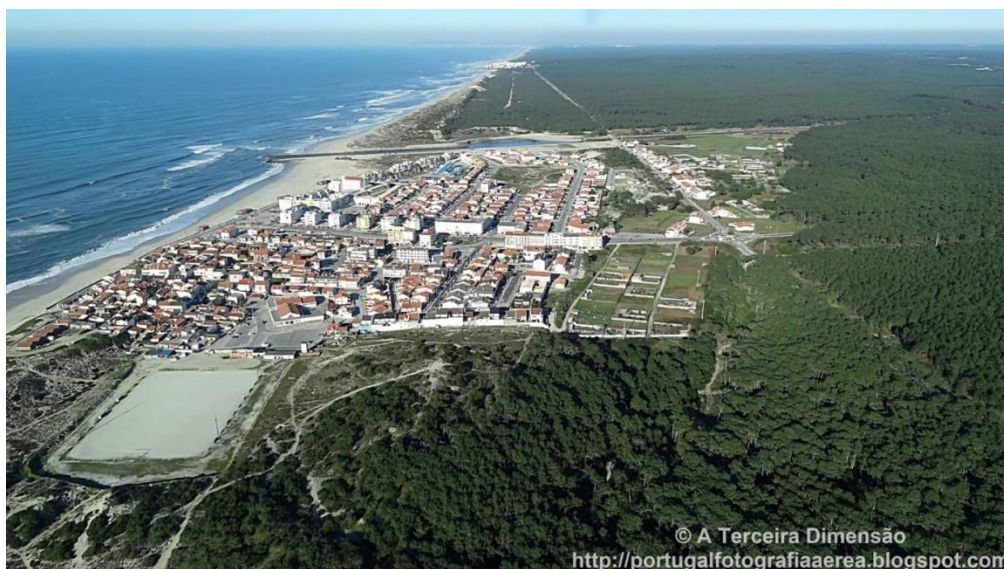
Figure 2.9 – Oblique aerial view of the seafront of Vieira beach

The coastal stretch of Vieira beach is a sandy beach - dune system with a coastline length of approximately 1 km and main alignment 19°N. It is located south of the south jetty of the Lis river mouth and includes the seafront of Vieira, part of Vieira de Leiria parish and city, in Marinha Grande council (from Figure 2.9 to Figure 2.12). The stretch evolved, since the last mid-century, under the influence of diverse human interventions (Cabral, 1986; Dias *et al.*, 1994; Cunha *et al.*, 1997; Oliveira *et al.*, 2004). Among those, the following stand out:

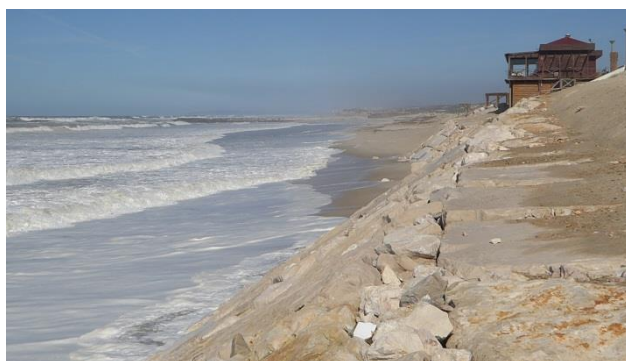
Figure 2.11 – Photographs of Vieira beach in the alongshore defence structure: towards the north sector (above, on the 19/Feb/2019) and towards the south sector (below, on the 4/Feb/2019, at left, and on the 25/Feb/2019, at right)

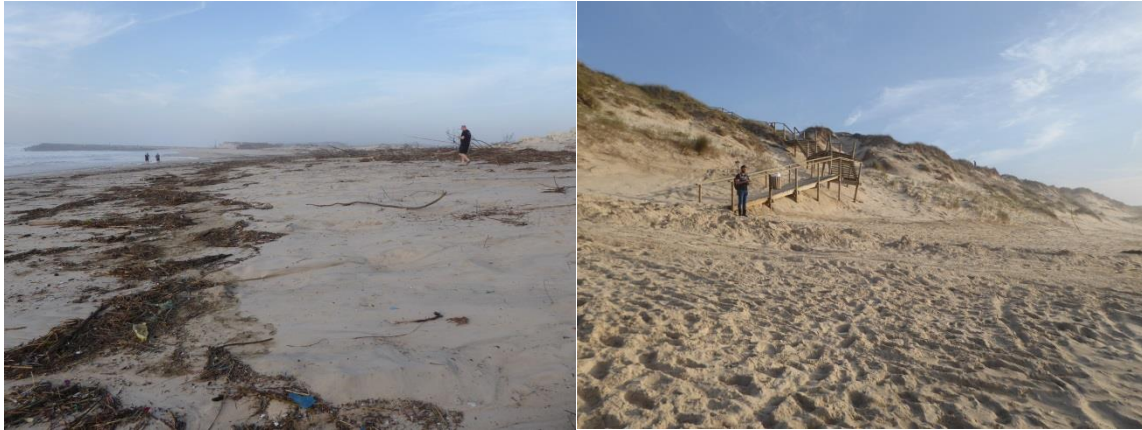
Figure 2.12 – Photographs of the extremes of Vieira beach: north (left) and south (right) (both on the 25/Feb/2019)

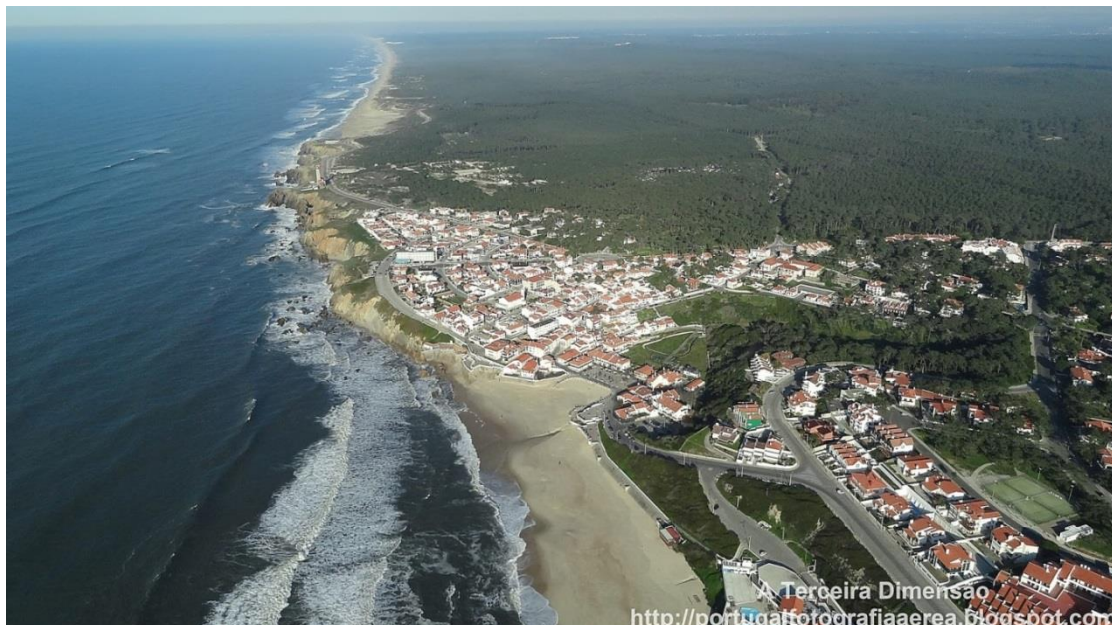
Figure 2.13 – Oblique aerial view of the seafront of São Pedro de Moel beach

The São Pedro de Moel beach is an embedded narrow beach with a coastline length of approximately 400 m and main alignment 25°N. It is located south of a 2 km length active cliff carved in consolidated rocks and includes the part of the seafront of the São Pedro de Moel village, part of Marinha Grande parish, city and council (from Figure 2.13 to Figure 2.17). The beach backshore is limited by a seawall with varying height (with some infrastructures on the top), an alongshore defence structure and an active cliff carved in consolidated rocks at both extremes. The beach surface is dug in the cross-shore direction, in a channel shape, by the São Pedro stream, whose outlet, covered by blocks of concrete, is located at the base of the seawall (Figure 2.14). Both extremes of the beach are characterised by the presence of low rocky outcrops, which are alternately covered and uncovered by sand.

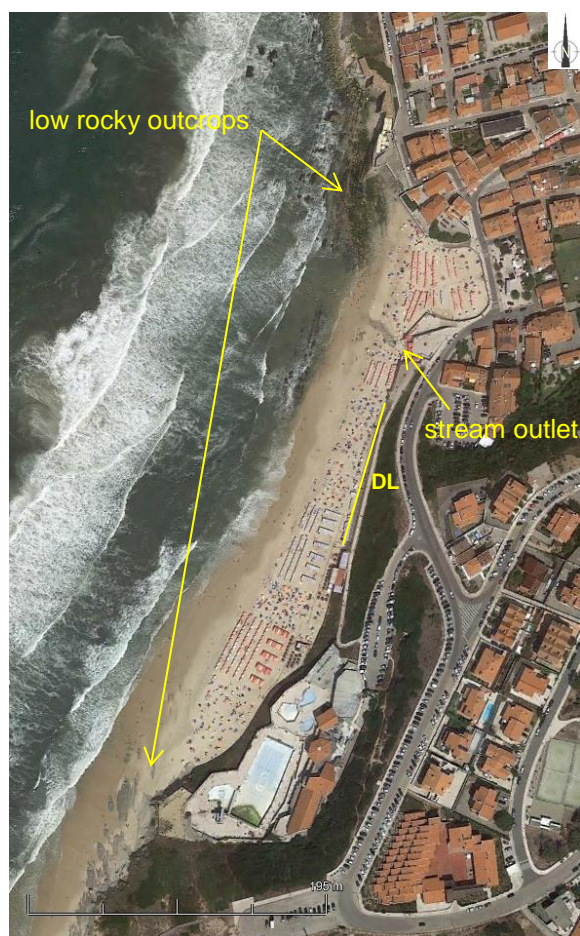
Figure 2.14 – Aerial photograph (dated of 18/8/2018; © Google Earth) of São Pedro de Moel beach and location of the low rocky outcrops, the stream outlet and the alongshore defence structure (DL)

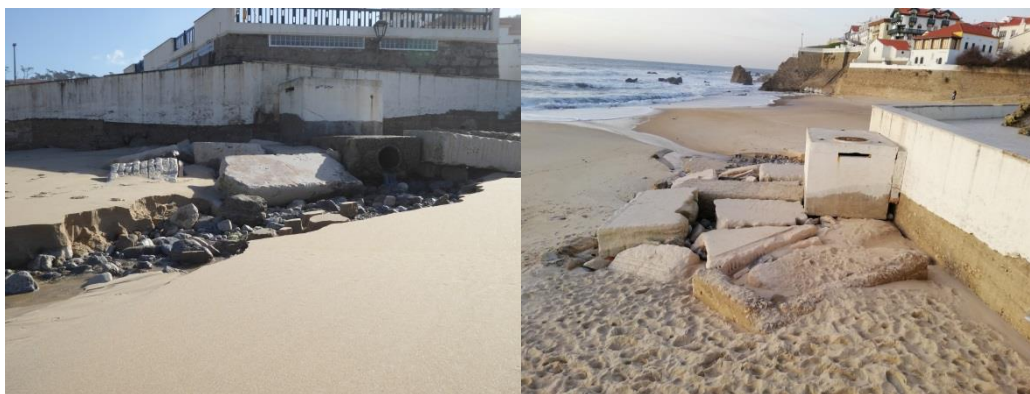
Figure 2.15 – Photographs of the São Pedro stream outlet and induced local erosion in São Pedro de Moel beach (Feb/2019)

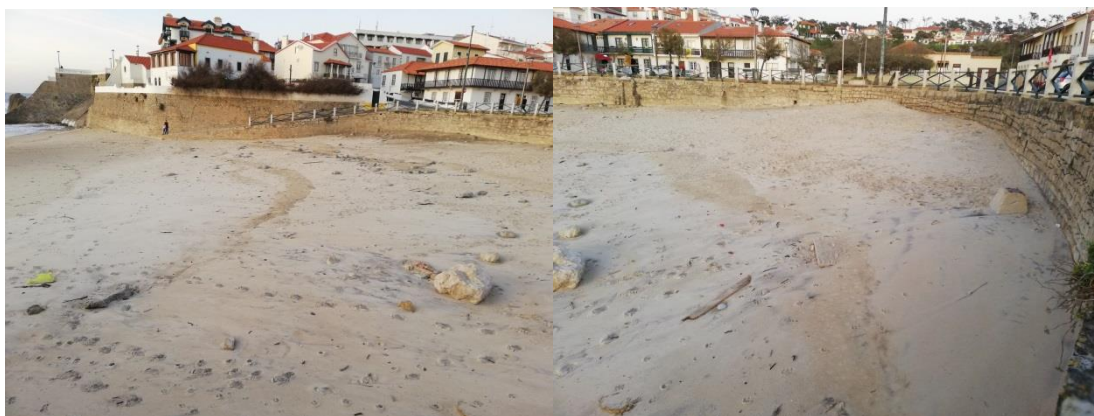
Figure 2.16 – Photographs of the northern sector of São Pedro de Moel beach (11/Feb/2019), from the sea towards the backshore (left to right)

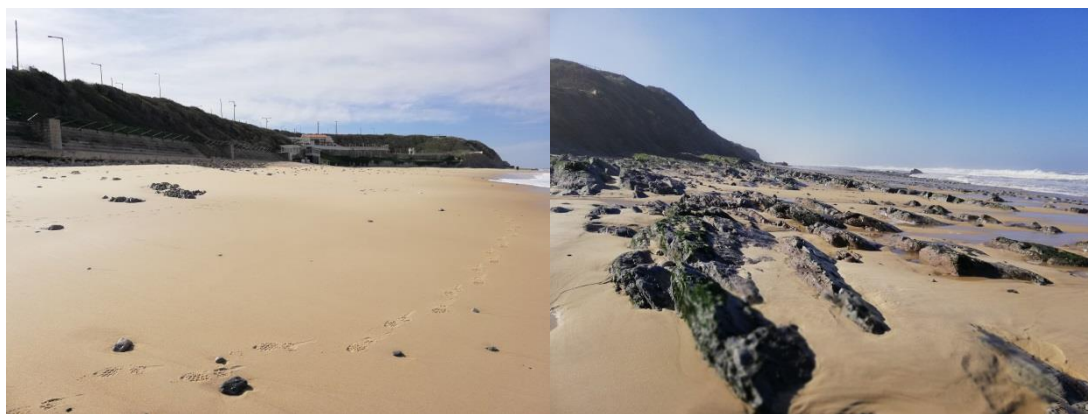
Figure 2.17 – Photographs of the central and southern sectors of São Pedro de Moel beach (left photo: 26/March/2019; right photo: 19/Feb/2019), from the backshore towards the sea

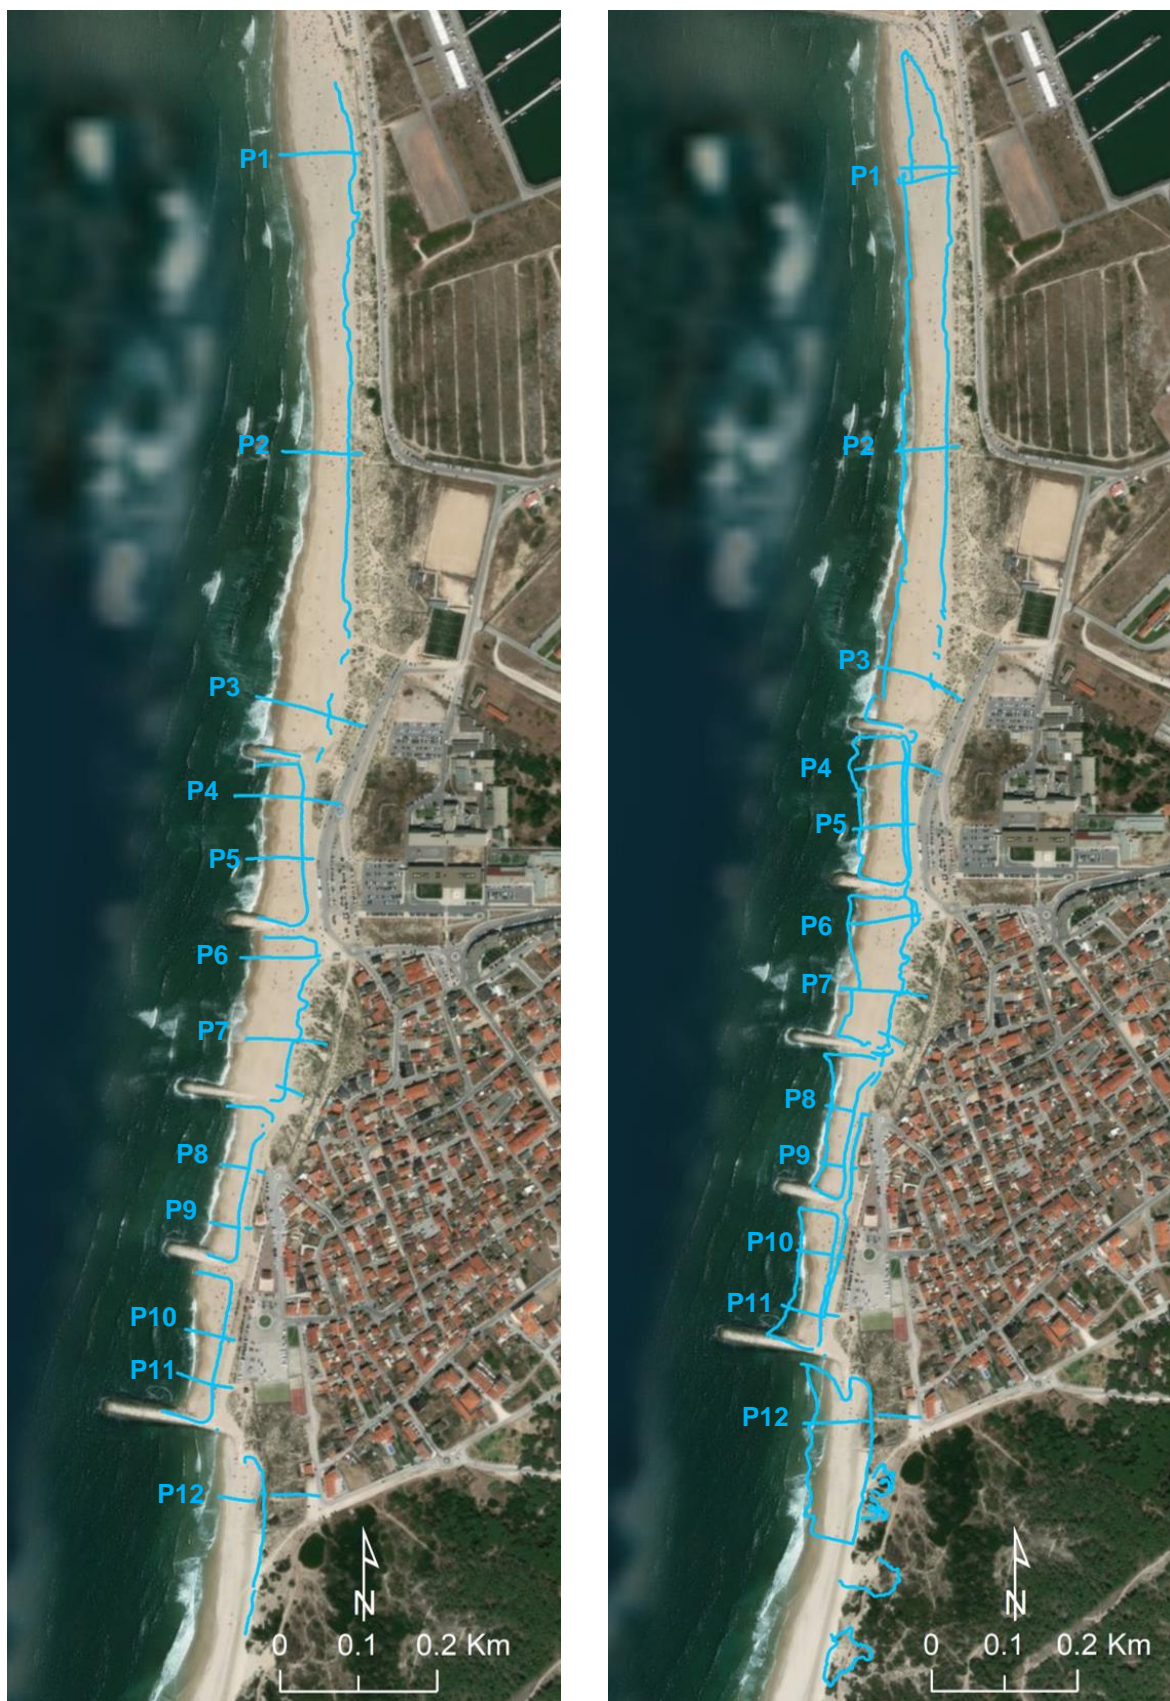
Figure 5.1 – Location of the topographic elements surveyed in Cova-Gala beach in the campaigns of 4/Feb/2019 and 21/Feb/2019, left and right, respectively. Image: ESRI Basemap

The surveys were performed by RTK using a Topcon Hiper Pro GNSS receiver. The position of the fixed station was obtained by static processing and the corrections were applied to the points surveyed. The fixed station was positioned on the land extreme of E5 (coordinates in PT-TM06/ETRS89: X=-62317.13 m, Y=50866.98 m; and orthometric height: Z=6.95 m), in the four campaigns (Figure 5.3). The reference position of each of the twelve topographic profiles, from P1 to P12 (in Figure 5.1 and Figure 5.2), is identified in Table 5.2.

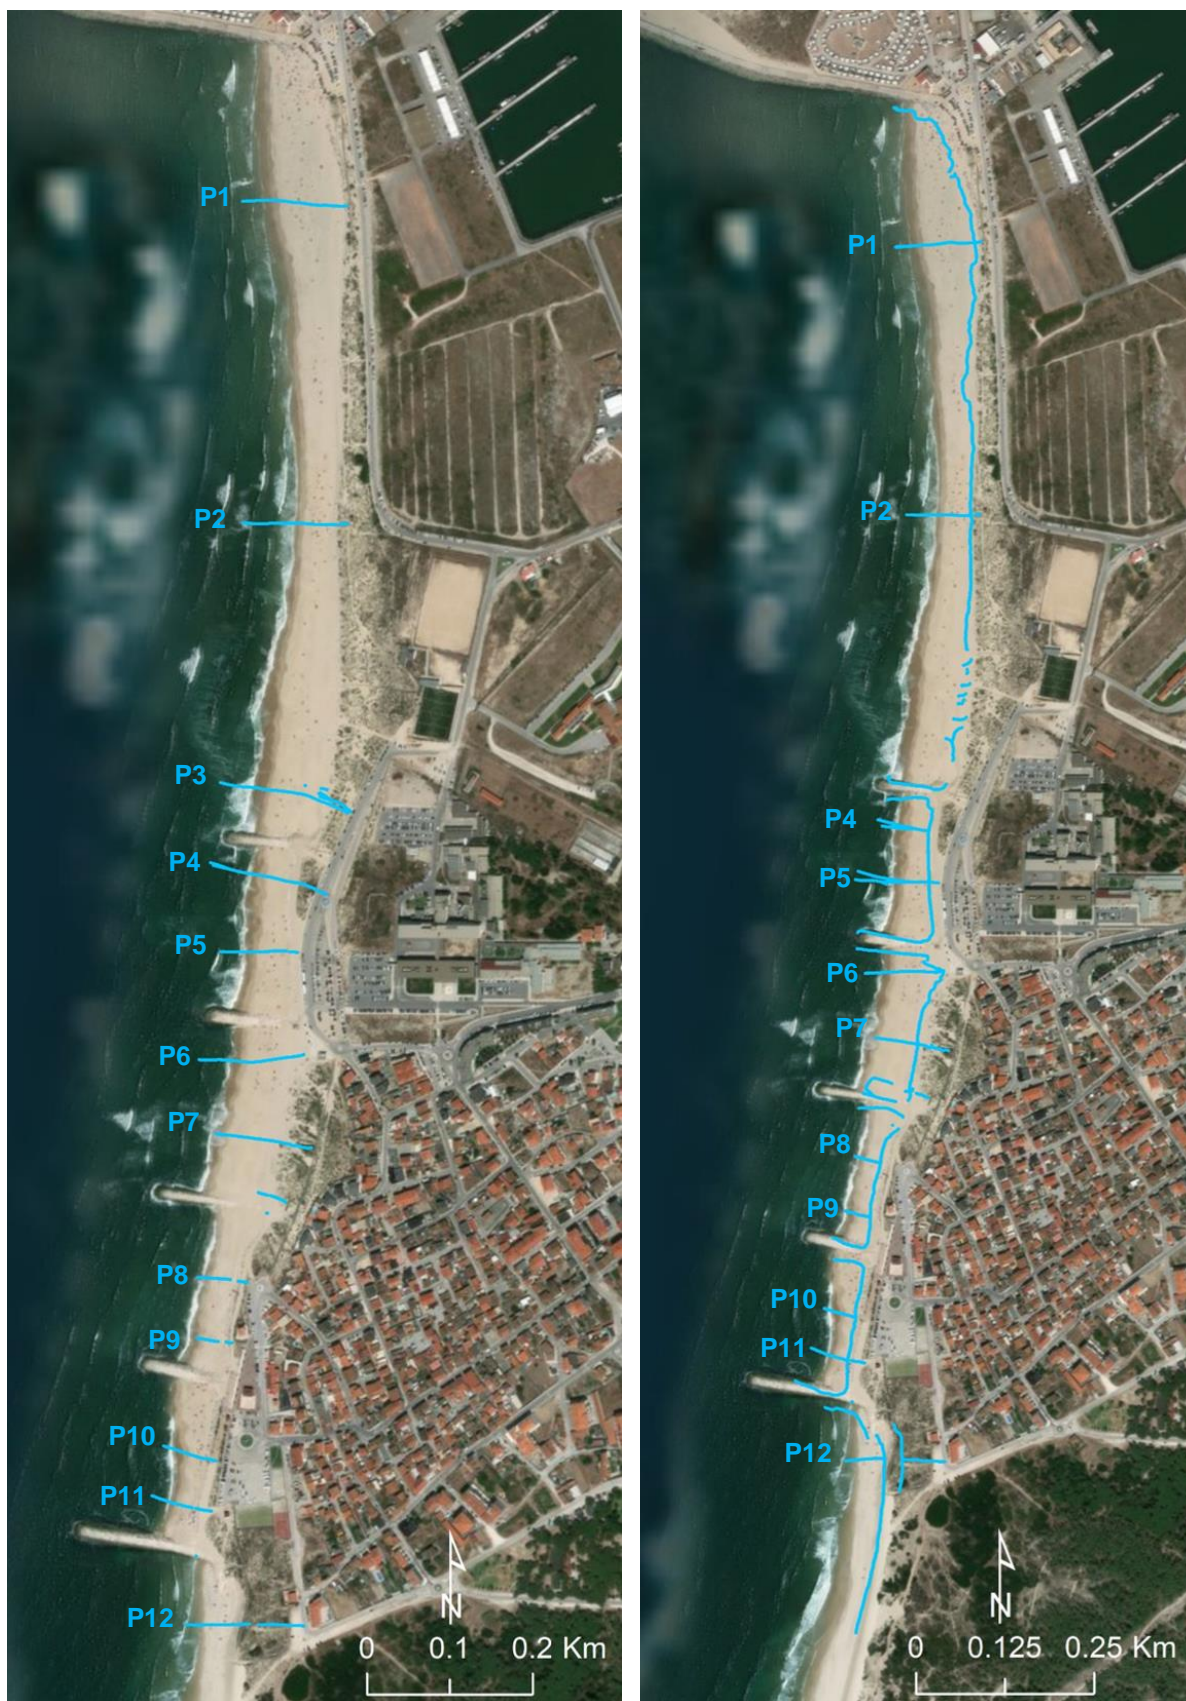
Figure 5.2 – Location of the topographic elements surveyed in Gala-Cova beach in the campaigns of 25/Feb/2019 and 26/March/2019, left and right, respectively. Image: ESRI Basemap

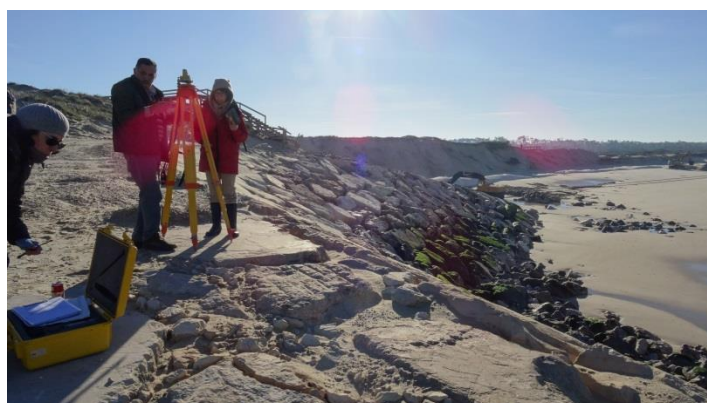
Figure 5.3 – Photograph of the positioning of the fixed station of the GNSS receiver on the campaign of 04Feb/2019: land extreme of E5; view towards south

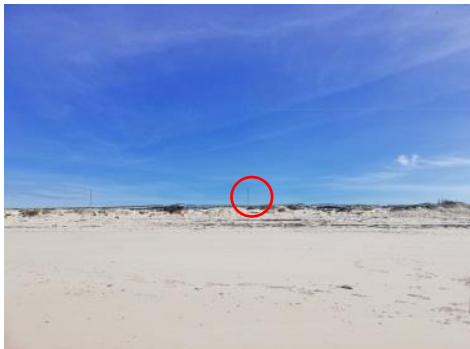
Topographic profile designation	Coordinates of the reference position (PT-TM06/ETRS89)	Notes and photographs of the reference position
P1	X = -62135.06; Y = 52502.51	<p>Last of the four wooden posts (when counting from north to south) located over the dune at the northern extreme of the beach, immediately adjacent to the south jetty of the Mondego river mouth.</p>

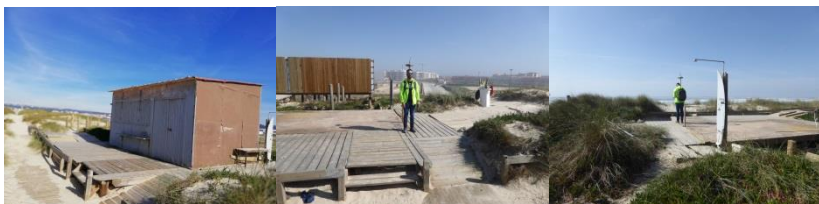
P2	X = -62133.35; Y = 52117.65	<p>Left limit (when facing the sea) of the wooden footbridge in front of the left limit of the surf school cabin (which was later demolished).</p>

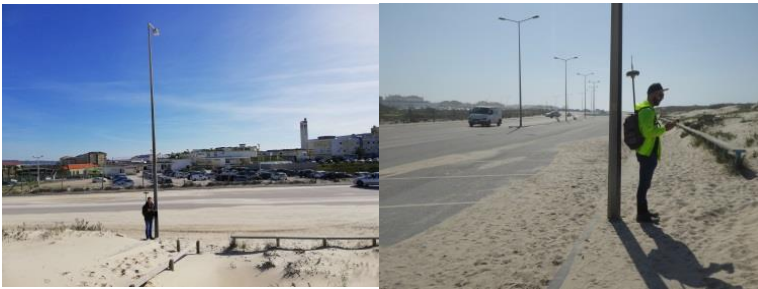
<b>P3</b>	X = -62130.09; Y = 51768.73	First street tower lamp located at the beach side of the street after the parking place, towards north.

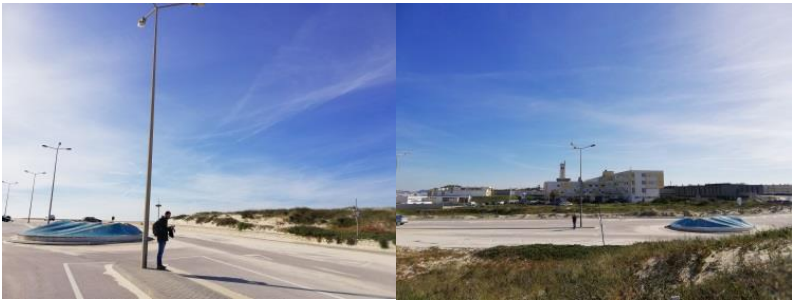
<b>P4</b>	X = -62159.92; Y = 51668.54	Street tower lamp positioned in the corner of the pedestrian platform located in the middle of the street in front of a roundabout (with a blue wave sculpture) in front of the hospital.

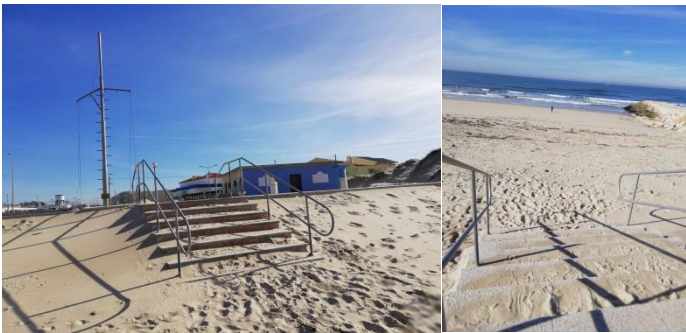
<b>P5</b>	X = -62194.71; Y = 51598.39	Left steel handrail (when facing the sea) of the concrete stair located at the north limit of the backshore of the sedimentological cell between E2 and E3 (the stair gives access to the parking place in front of the hospital).

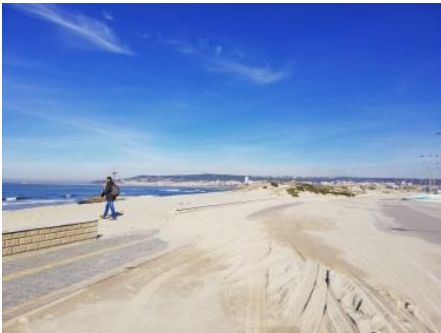
<b>P6</b>	X = -62186.49; Y = 51474.70	South limit of the northern stretch of the wall that limits the pedestrian platform in front of the parking place, in front of the hospital.

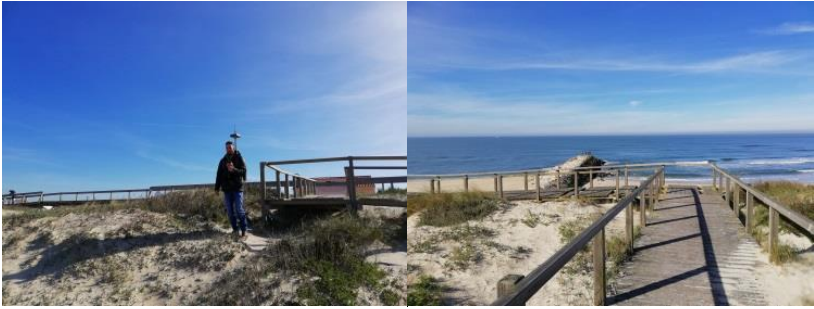
<b>P7</b>	X = -62177.52; Y = 51361.37	Corner of the wooden footbridge at the south limit of the backshore of the sedimentological cell between E2 and E3.

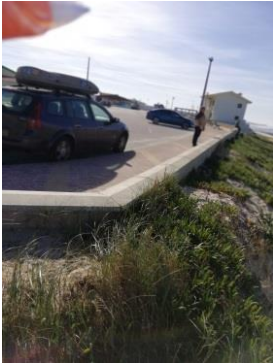
<b>P8</b>	X = -62255.27; Y = 51198.50	Corner of the north limit of the wall that limits the pedestrian platform of the seafront of the sedimentological cell between E3 and E4.

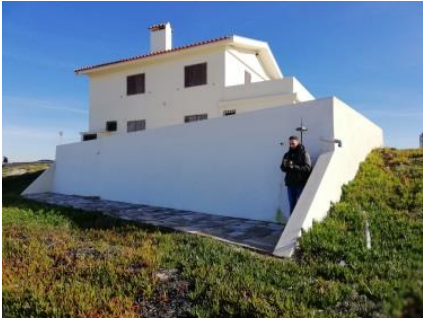
<b>P9</b>	X = -62273.54; Y = 51125.43	Left corner of the wall (when facing the sea) of the backyard of the house located over the alongshore defence of the sedimentological cell between E3 and E4.

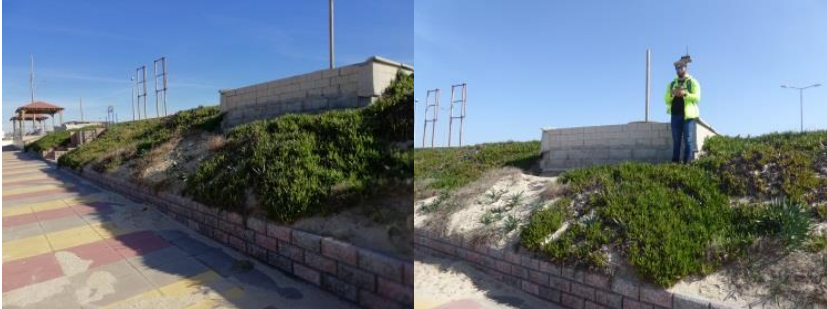
<b>P10</b>	X = -62292.75; Y = 50982.32	Left corner (when facing the sea) of the third picnic box (counting from south to north) in front of the sedimentological cell between E4 and E5.

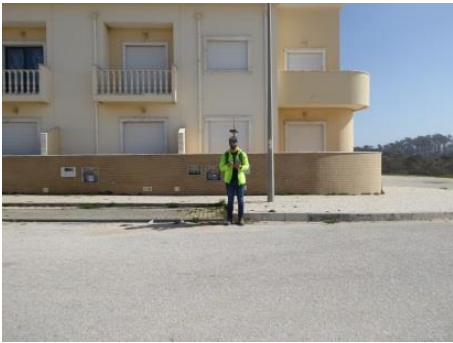
<b>P12</b>	X = -62186.72; Y = 50782.59	Corner of the pedestrian platform, near the street tower lamp, in front of the yellow block of apartments.

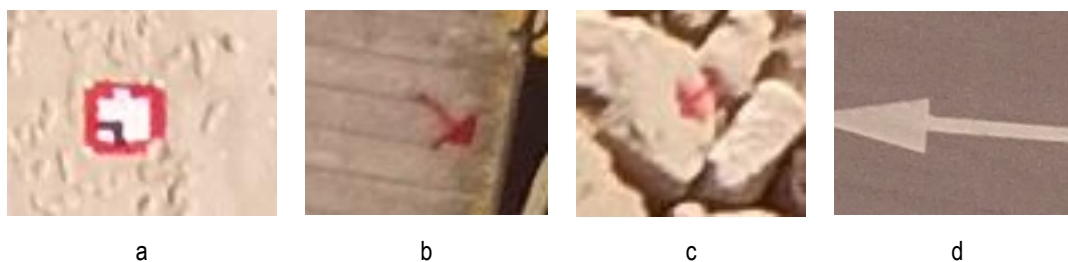
Figure 5.6 – Points coordinated as seen on the aerial photographs on 11/Feb/2019

The points were materialized by: i) targets, made with sheets of plastic (Figure 5.6a), placed on the sand; ii) triangular targets painted with red or white ink on the pedestrian platforms on the dunes area (Figure 5.6b) or on the surface of the blocks of the groynes (Figure 5.6c); iii) pre-existing local features (Figure 5.6d). All these points had to be visible on the aerial photos.

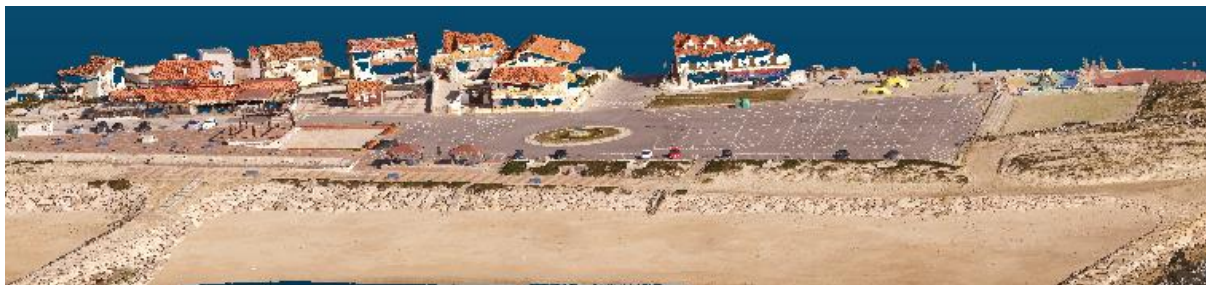
Figure 5.7 – Point cloud of the Cova-Gala beach, between E4 and E5, and the nearby area on 11/Feb/2019

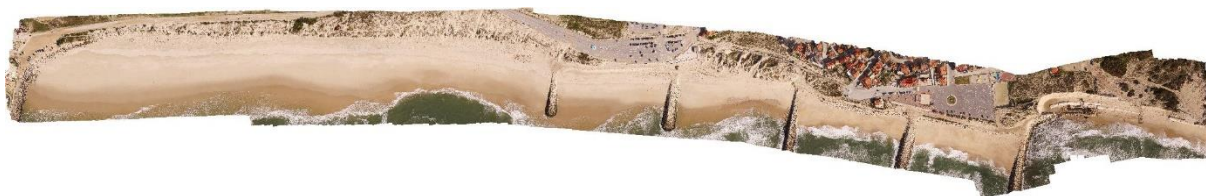
Figure 5.8 – Orthomosaic of Cova-Gala beach on 11/Feb/2019

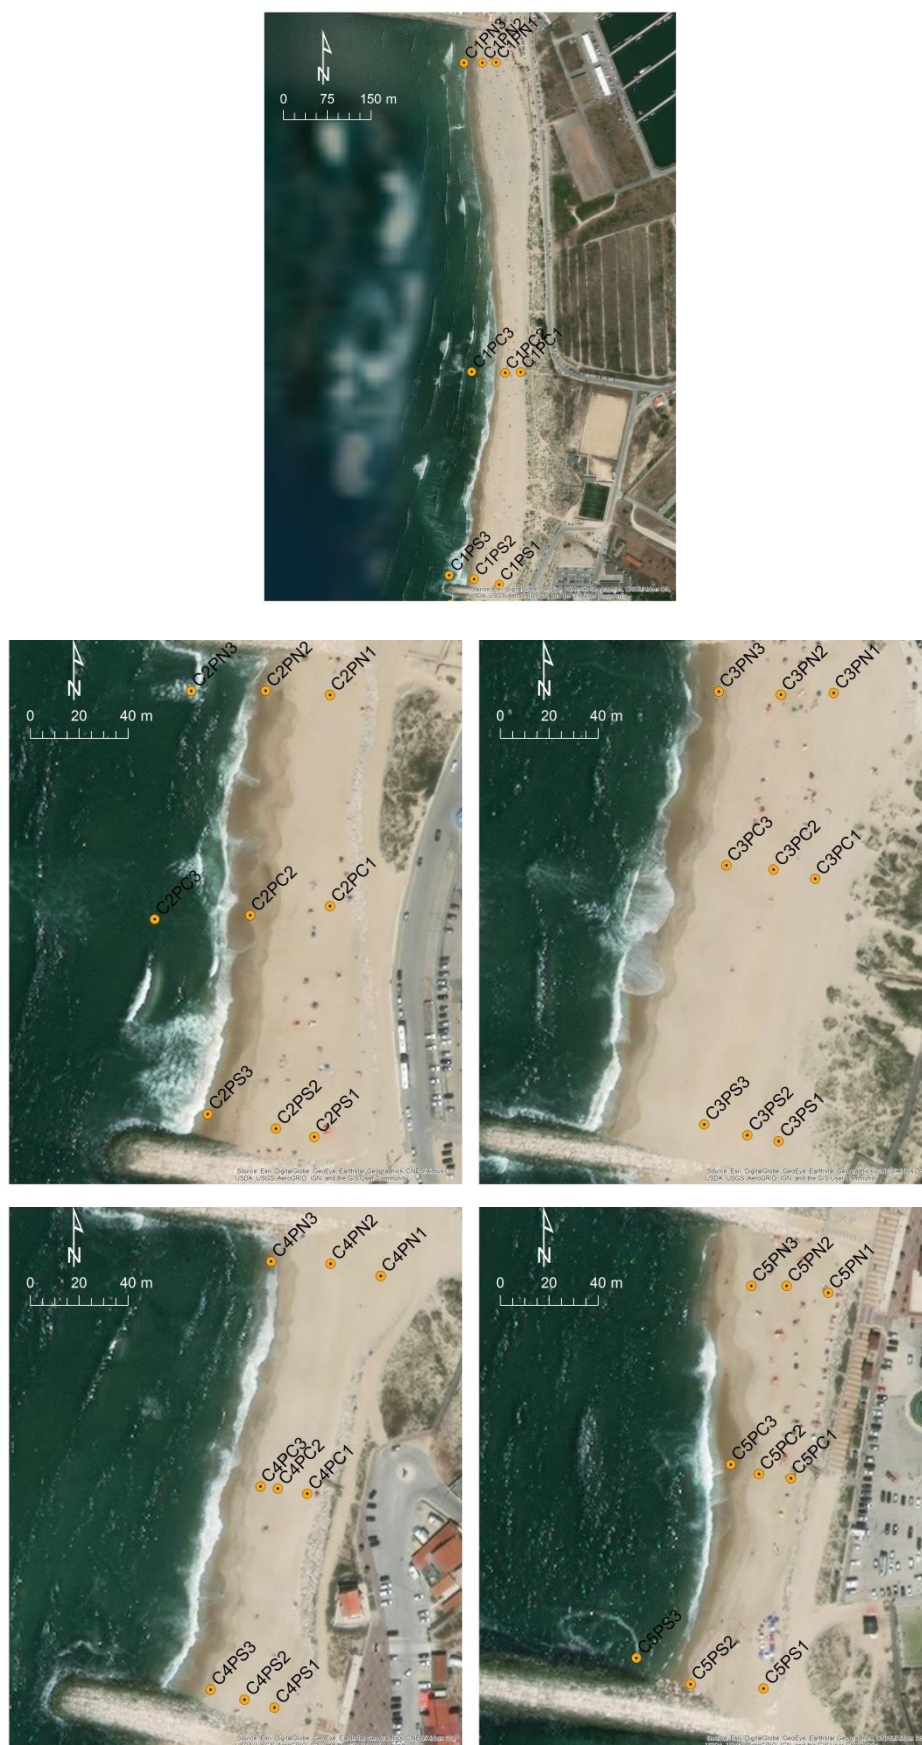
Figure 5.13 – Location of the sediment samples collected on 04/Fev/2019 from north to south for each sedimentological cell. Image: ESRI Basemap

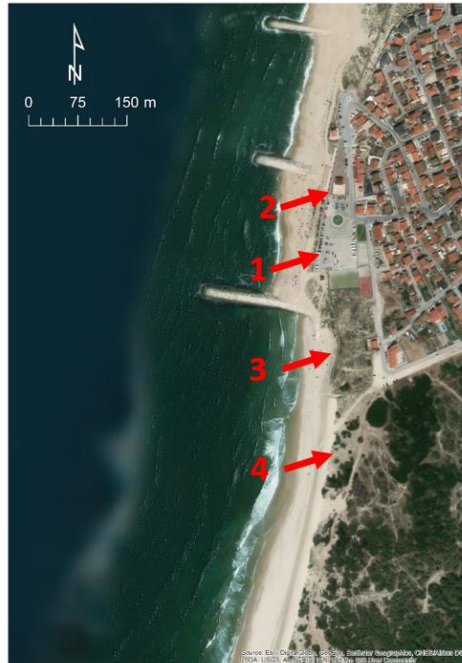
Figure 5.14 – Location of the territorial elements affected in Cova-Gala beach and described in Table 5.3

To characterize how the different coastal typologies presented in the Cova-Gala beach were affected by the forcing conditions observed during the field campaigns, information about territorial elements affected was acquired. The information includes the evidence of coastal defences overtopping and dune overtopping and overwash and is summarized in Table 5.3. The locations of the evidences are identified Figure 5.14.

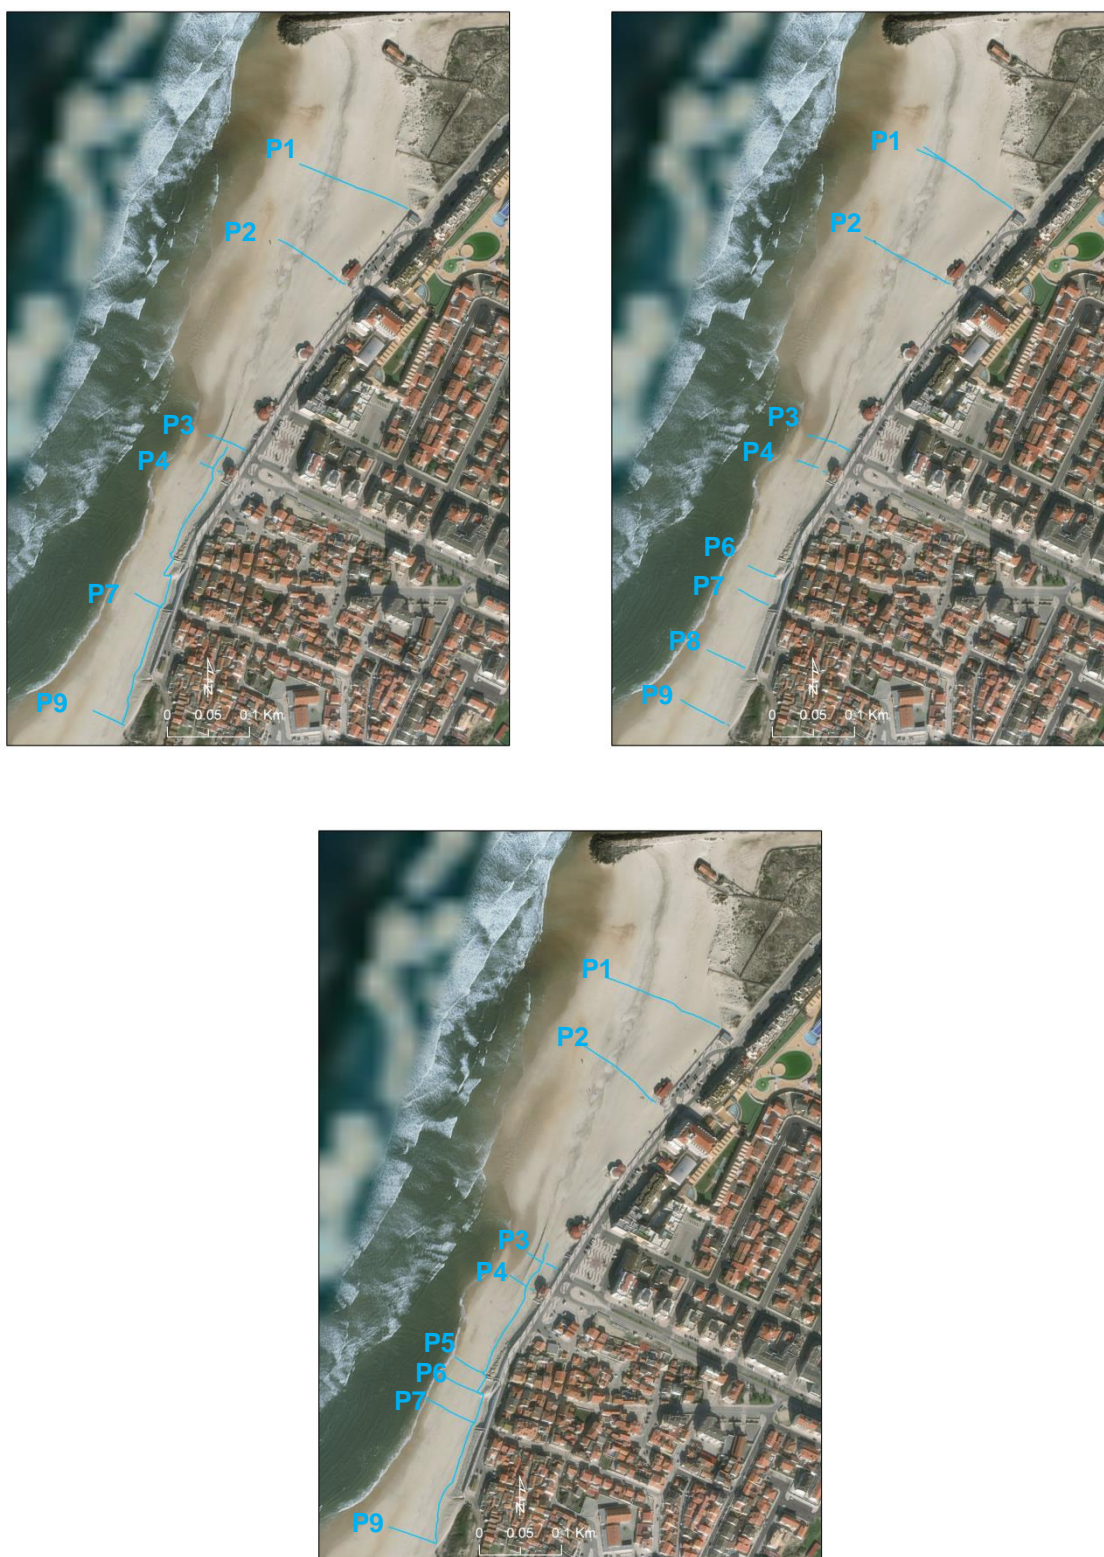
Figure 6.1 – Location of the topographic elements surveyed in Vieira beach in the campaigns of 19/Feb/2019 and 25/Feb/2019 (left and right, above) and of 26/March/2019 (below). Image: ESRI Basemap

The reference position of each of the seven topographic profiles, from P1 to P9 (in Figure 6.1), is identified in Table 6.2.

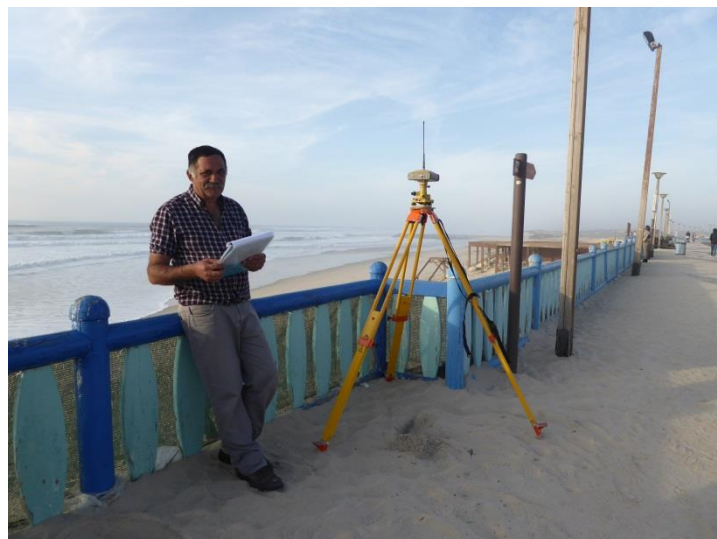
Figure 6.2 – Photograph (view towards north) of the positioning of the fixed station of the GNSS receiver on the campaign of 25/Feb/2019: pedestrian platform in front of the roundabout with the boat sculpture, north of the Sun7 Bar

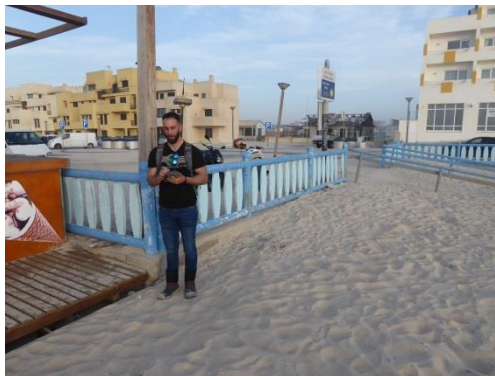
- 
- P2**       $X = -71657.77$ ;  
              $Y = 23471.94$       Corner of the fencing of the coffee shop on the top of the beach.

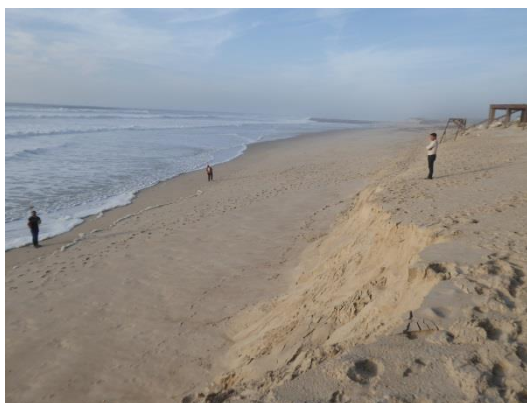
- 
- P3**       $X = -71779.74$ ;  
              $Y = 23269.04$       Cross-shore direction that intercepts the fixed station of the GNSS receiver.

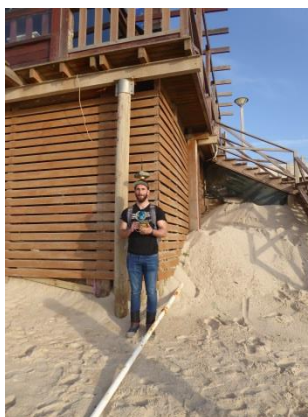
- 
- P4**       $X = -71807.84$ ;  
              $Y = 23241.58$       South corner of the coffee shop located further south.

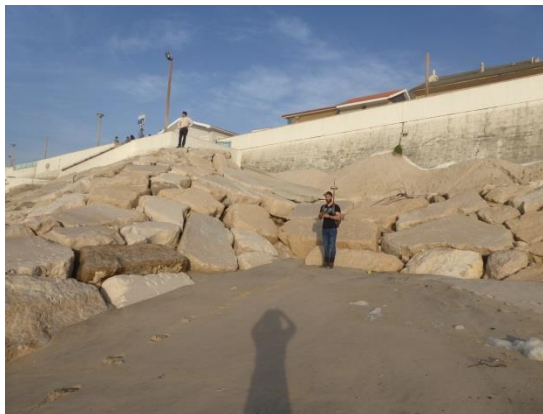
| <b>P6</b> | X = -71868.71;<br>Y = 23122.24 | End of the concrete ramp which gives access from the pedestrian platform to the beach at the south sector the beach. |

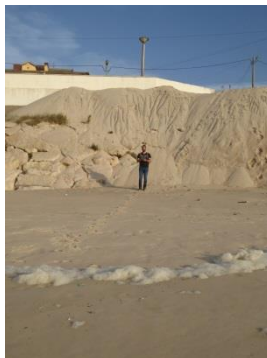
| <b>P8</b> | X = -71907.32;<br>Y = 23003.56 | Southern end of the alongshore defence structure. |

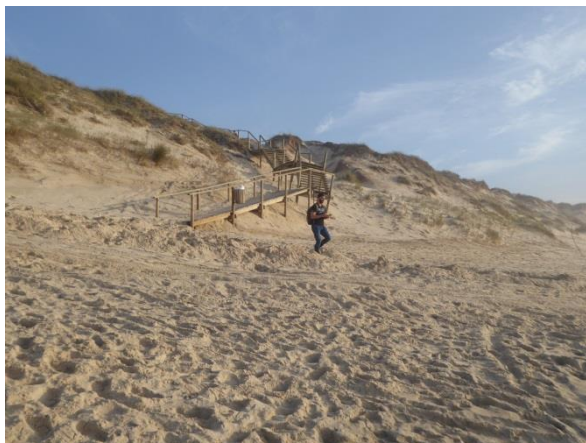
| <b>P9</b> | X = -71926.33;<br>Y = 22933.52 | End of the wooden footbridge located at the south extreme of the beach. |
