## **MOSAIC.PT FIELD CAMPAIGNS**

**Cova-Gala, Vieira and São Pedro de Moel beaches,  
January-March 2019**

MOSAIC.pt – Multi-source flood risk analysis for safe coastal  
communities and sustainable development

REPORT 334/2019 – **DHA/NEC**

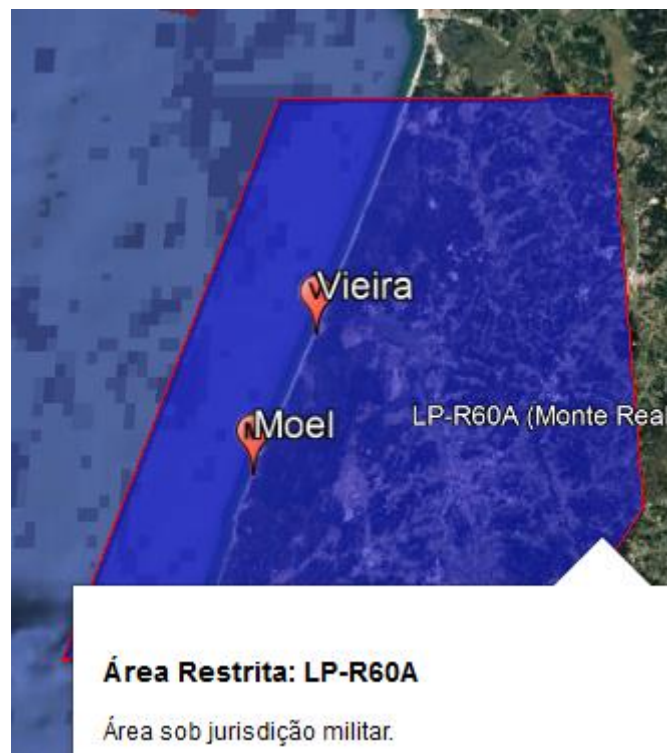
Figure 6.3 – Area with restrictions to flights due to the Air Force Military airbase of Monte Real

Besides the normal authorization to get the photos (described in 5.3), it was necessary to get, also from NAA, a special authorization to perform the flights over Vieira and São Pedro de Moel beaches, because both are located in a restricted area to flights, imposed by the vicinity of Air Force Military airbase located in Monte Real.

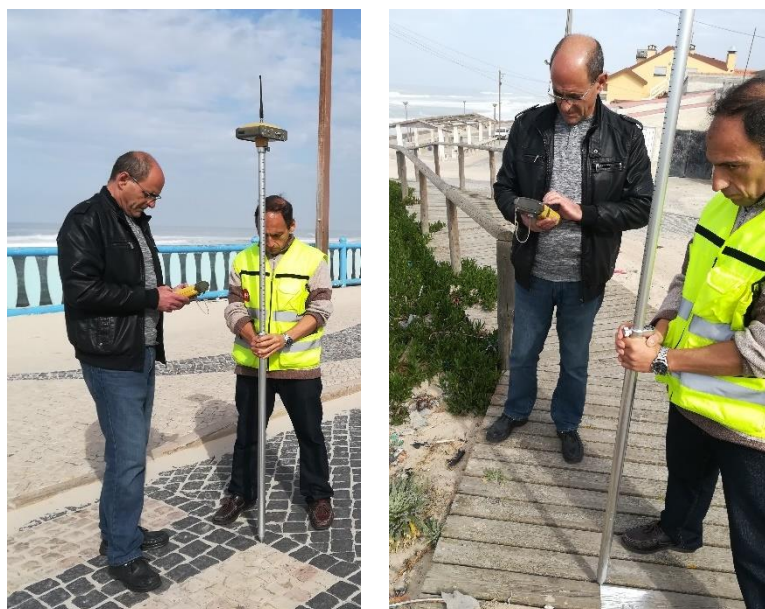
Figure 6.5 – Coordination of two points by GNSS-RTK in Vieira beach on 27/Feb/2019

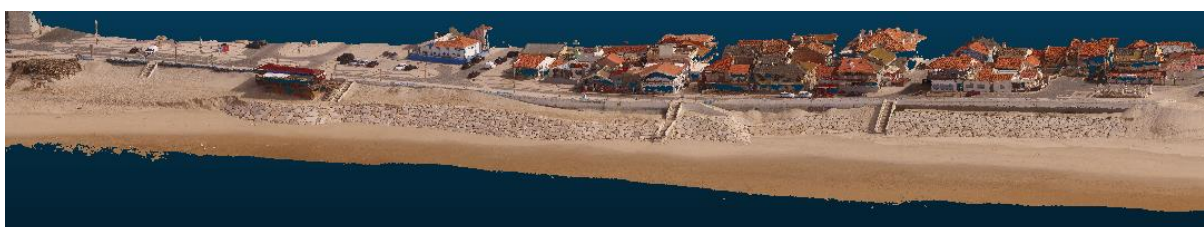
Figure 6.6 – Point cloud of the south area of Vieira beach and the nearby area on 27/Feb/2019

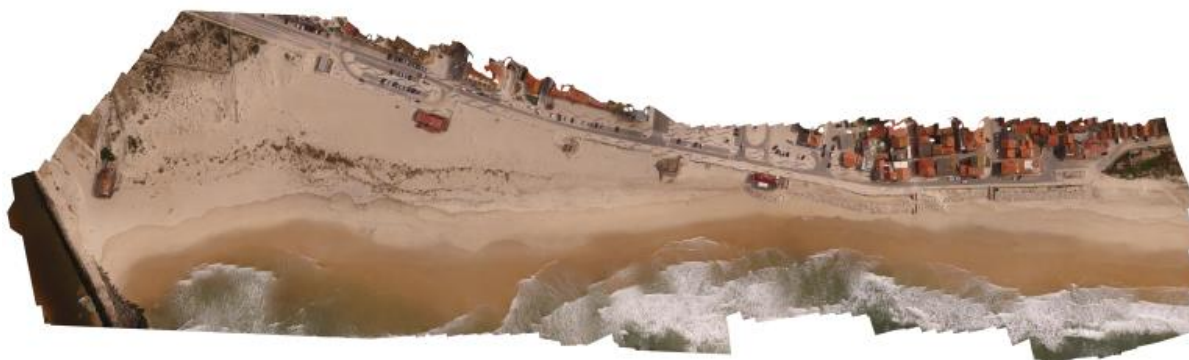
Figure 6.7 – Orthomosaic of Vieira beach on 27/Feb/2019

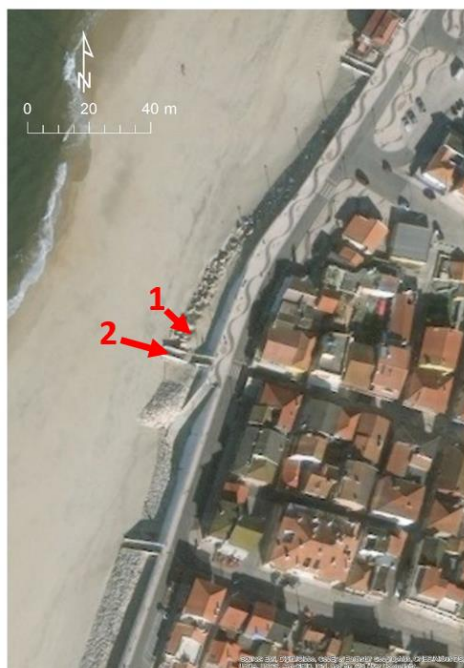
Figure 6.11 – Location of the territorial elements affected in Vieira beach and described in Table 6.3

The information about territorial elements in Vieira beach affected by the forcing conditions observed during the field campaigns is summarized in Table 6.3, and the evidences located in Figure 6.11.

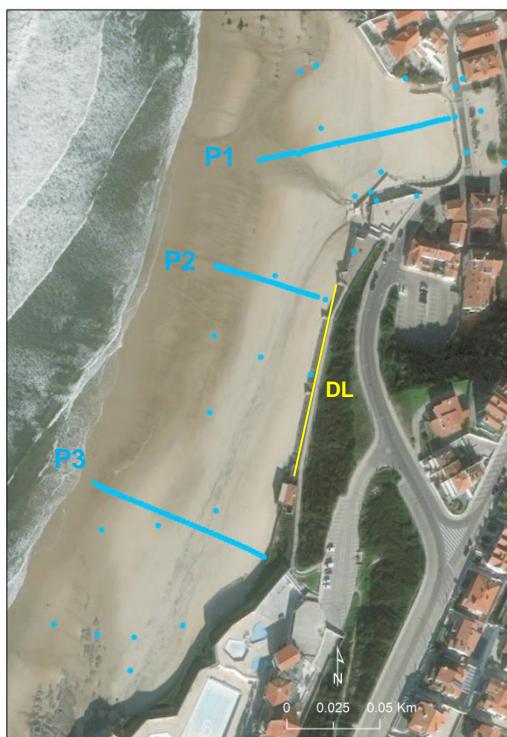
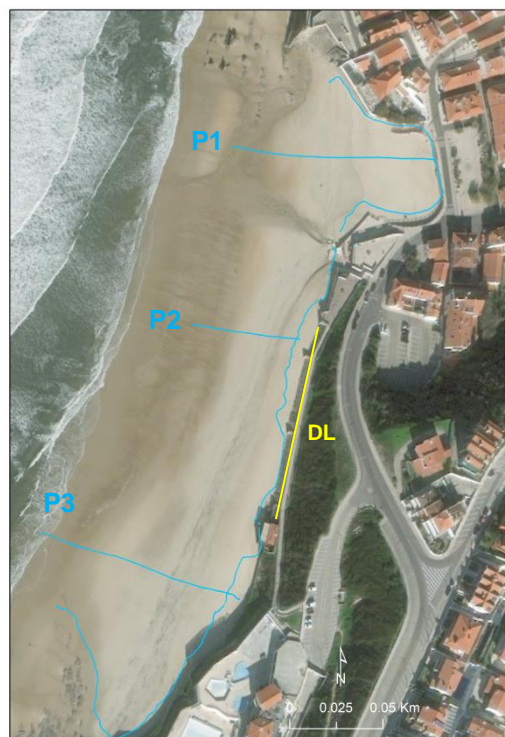
Figure 7.1 – Location of the topographic elements surveyed in São Pedro de Moel beach in the campaigns of 12/Feb/2019 and 19/Feb/2019, left and right, respectively. Image: ESRI Basemap

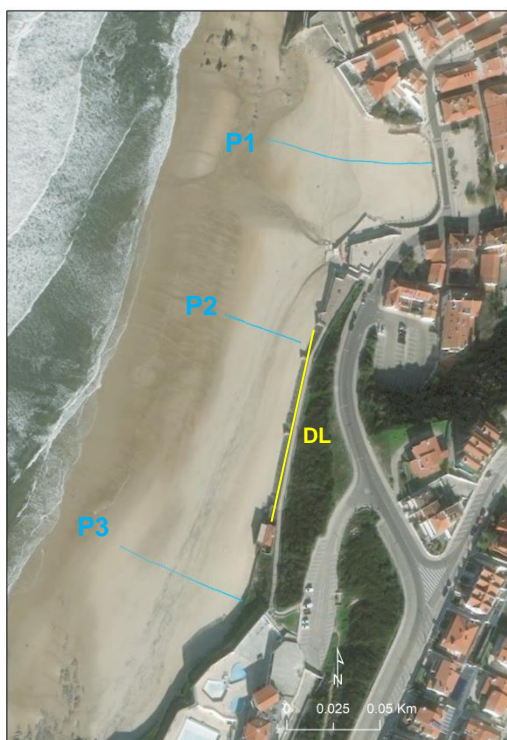
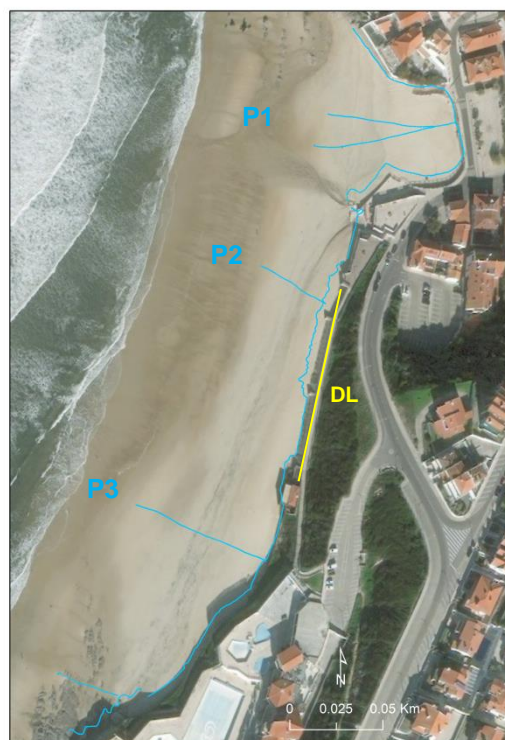
Figure 7.2 – Location of the topographic elements surveyed in São Pedro de Moel beach in the campaigns of 25/Feb/2019 and 26/March/2019, left and right, respectively. Image: ESRI Basemap

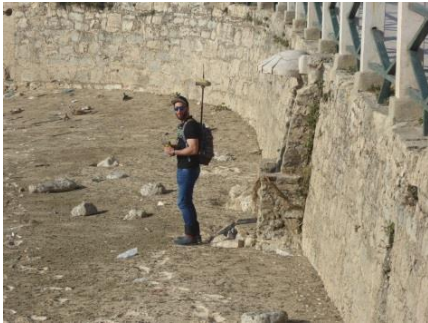
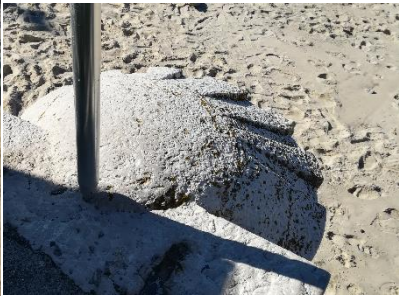
Topographic profile designation	Coordinates of the reference position (PT-TM06/ETRS89)	Notes on the reference position
P1	X = -77008.84; Y = 10114.56	Rearmost position of the beach backshore at the north sector. Old water source with a stone shell on top located at the pedestrian platform elevation. The first point coordinated was on the top of the stone shell.
<div>

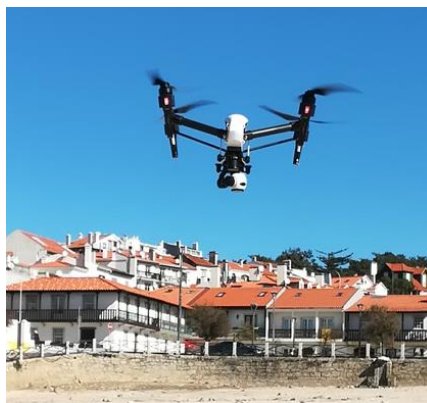
Figure 7.4 – Drone DJI Inspire 1 V2 take off in São Pedro de Moel beach on 12/Feb/2019

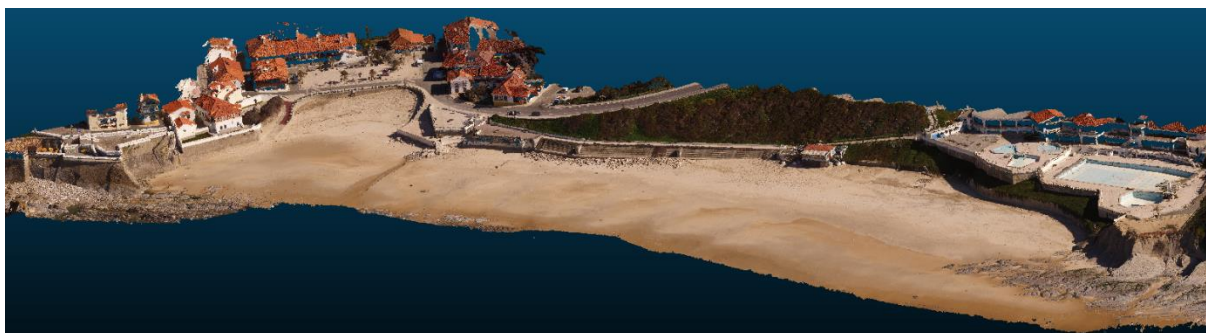
Figure 7.7 – Point cloud of the São Pedro de Moel beach on 12/Feb/2019

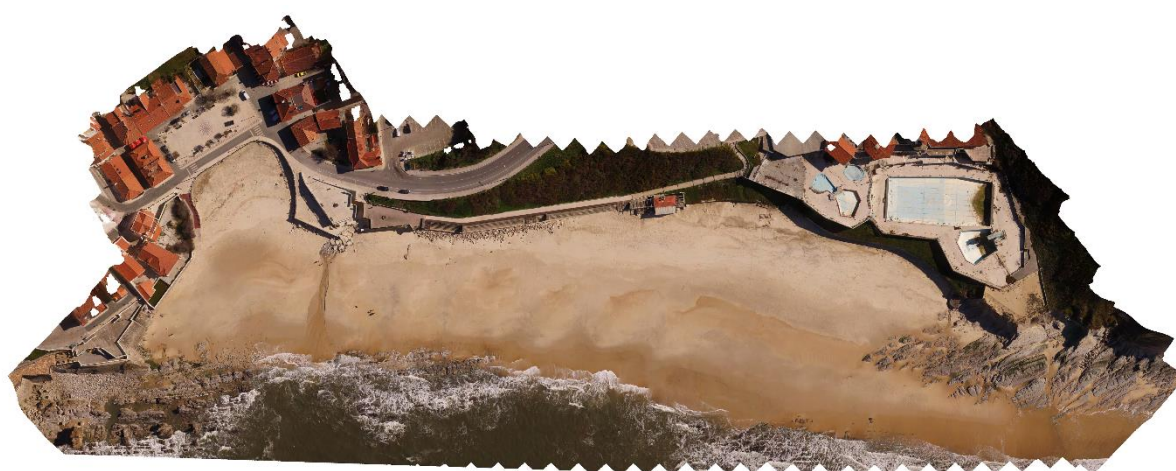
Figure 7.8 – Orthomosaic of São Pedro Moel beach on 12/Feb/2019

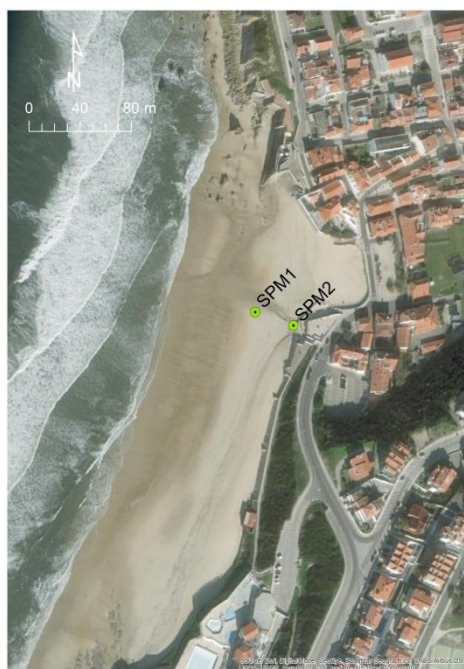
Figure 7.10 – Location of the sediment samples collected on 08/Jan/2019 in the São Pedro de Moel beach. Image: ESRI Basemap

Two superficial sediment samples were collected on 08/Jan/2019 in the São Pedro de Moel beach foreshore (Figure 7.10).
